Continuum FE models for the analysis of Mallorca Cathedral

Pere Roca, Miguel Cervera, Luca Pelà*, Roberto Clemente, Michele Chiumenti

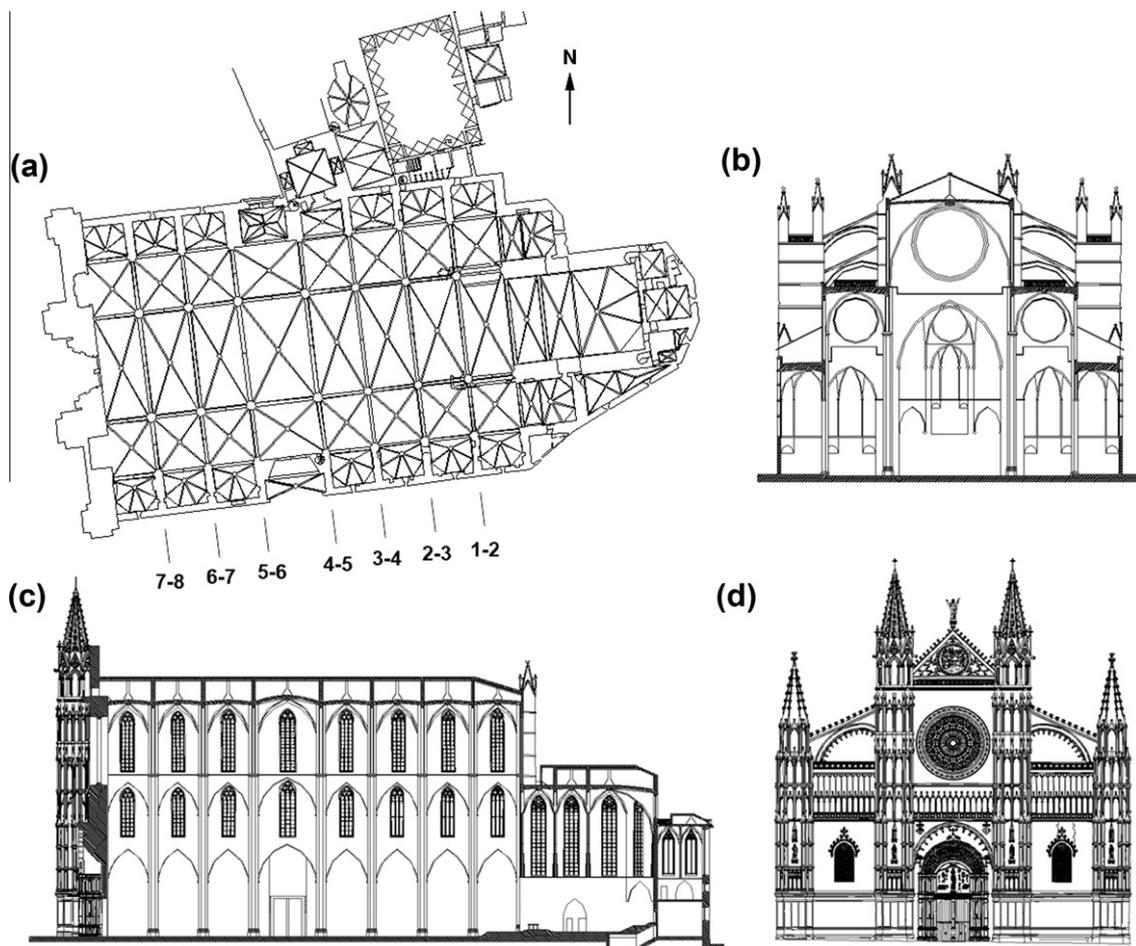
Fig. 2. Plan at roof level (a), transverse section (b), longitudinal section (c) and façade (d).

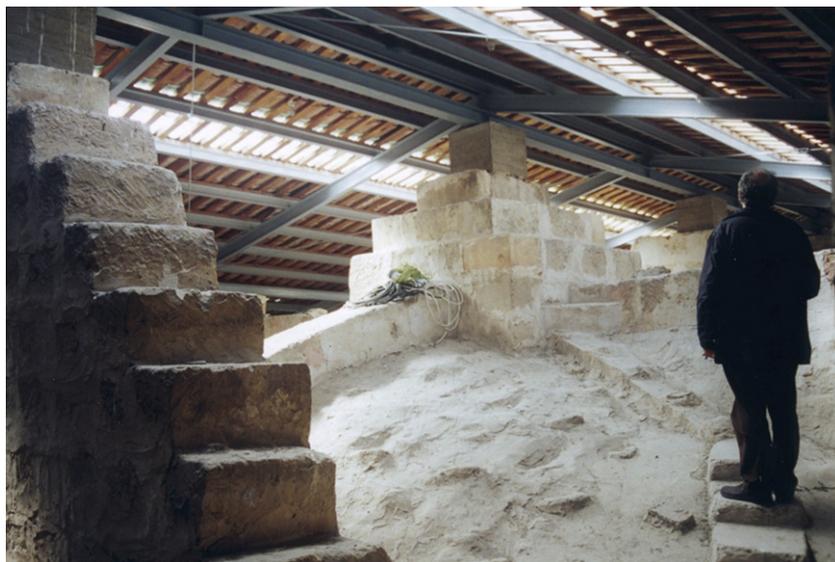
Fig. 3. Diaphragmatic arches with pyramidal dead weight over vaults.

A distinctive feature of Mallorca Cathedral is found in the large amount of dead weight laid over the transverse arches and central vault keystones (Fig. 3). Pioneering studies based on graphic statics [46] or photoelasticity [47] already showed that this extra load was actually needed for a satisfactory equilibrium condition. A detailed overview of preliminary structural studies carried out on Mallorca Cathedral using both limit analysis and FE modeling are presented in [48–50].

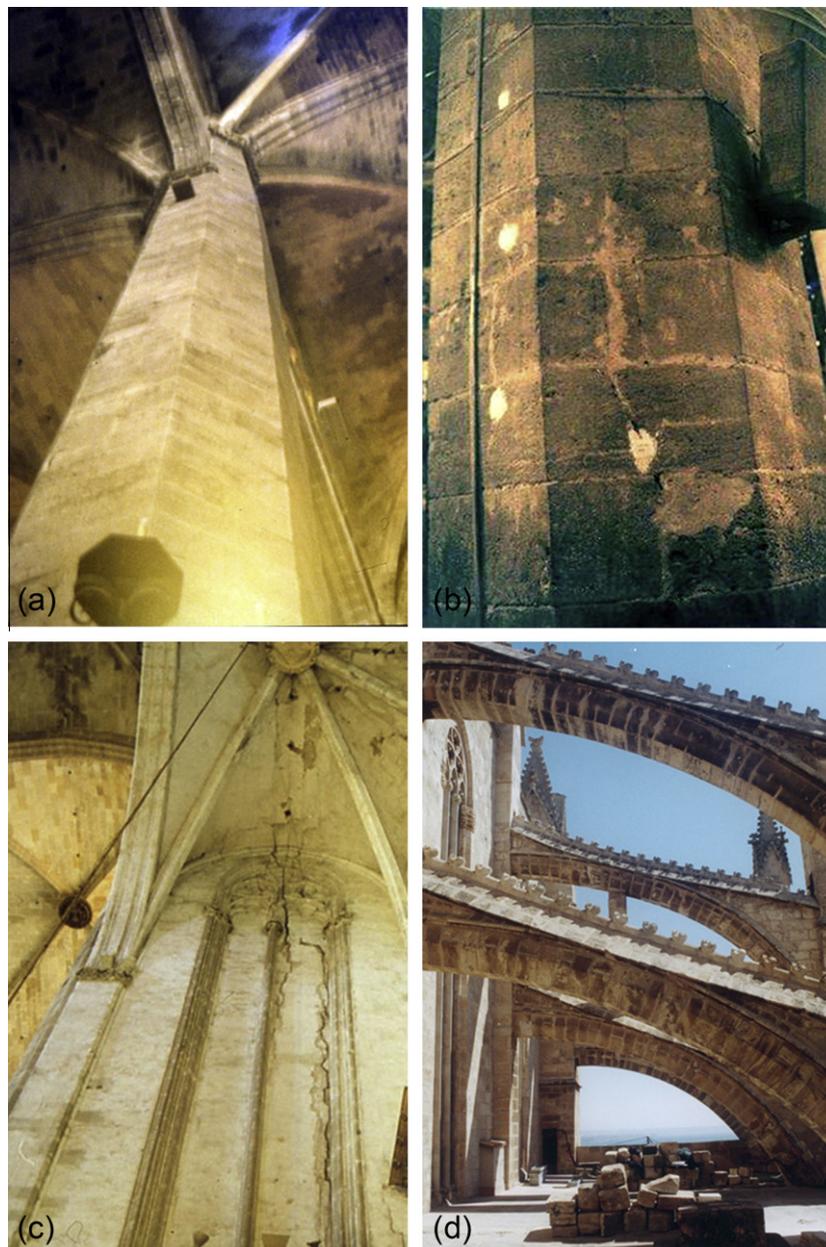
Fig. 4. Deformation at the top of a pier (a), cracks at the base of a pier (b), cracks in a buttress following the perimeter of a false window (c) and deformed flying arches (d).

parts of the building, as in particular in the piers, buttresses and flying arches (Fig. 4). Some of these cracks have been repaired during recent restoration works.

Flying arches, and particularly those of the upper battery, show also significant deflection (Fig. 4d). Part of this deformation may be due to the overall deformation of the structure and, particularly, to the outward rotation of flying arches. However, other non-mechanical effects may have as well contributed to this apparent deflection, among which the deformation of the centerings used during the construction and later loss of mortar in joints due to chemical problems. The mortar joints of flying arches had to be repeatedly repaired, as can be inferred from inspection and is also described in available historical documents.

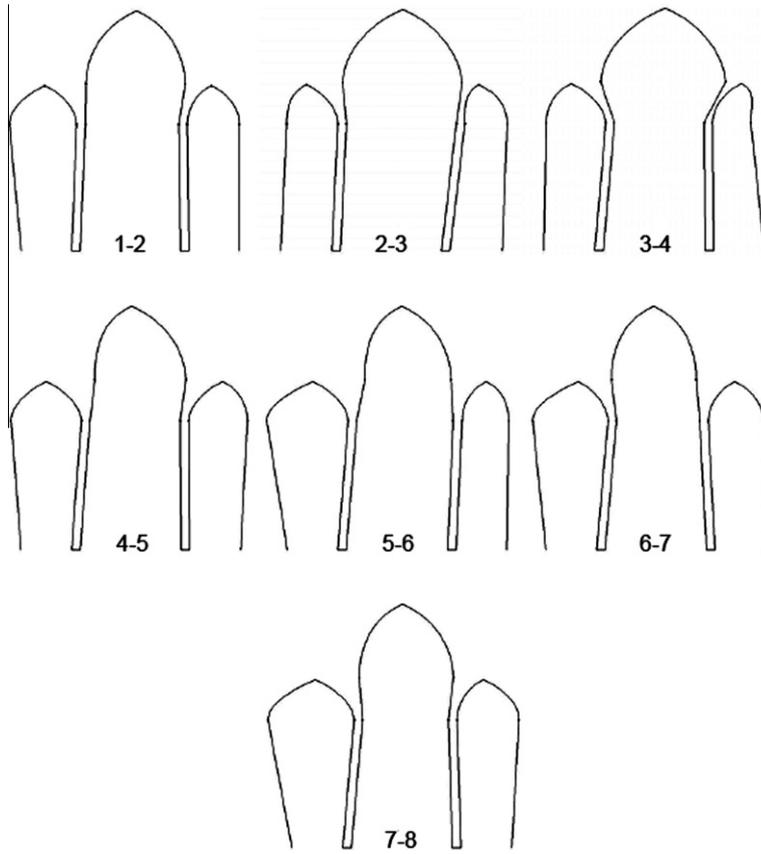
Fig. 5. Observed deformed shapes of the nave transverse sections.

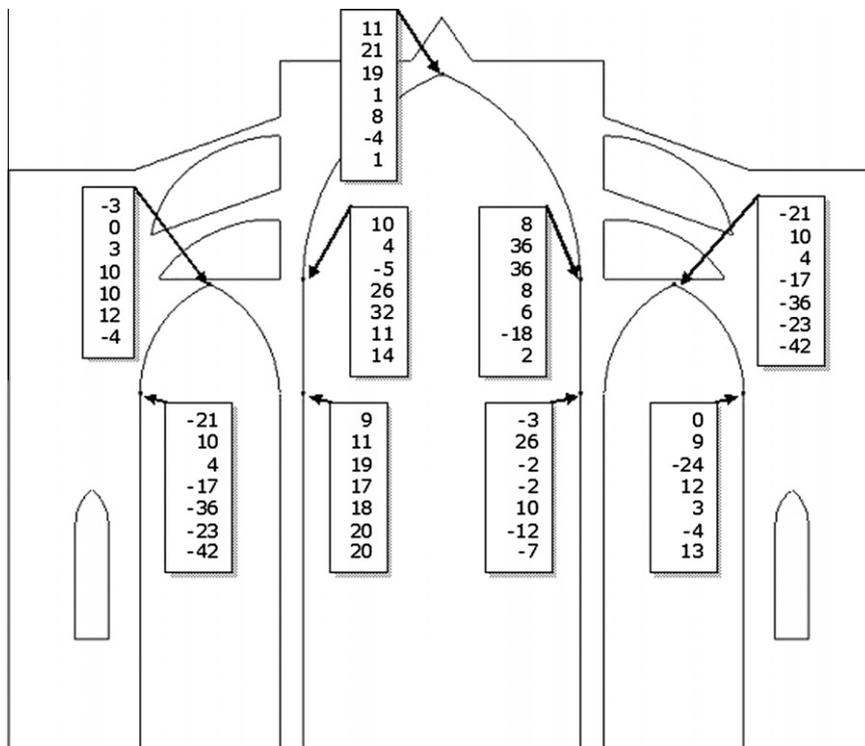
Fig. 6. Horizontal displacements (in cm) of the nave transverse sections.

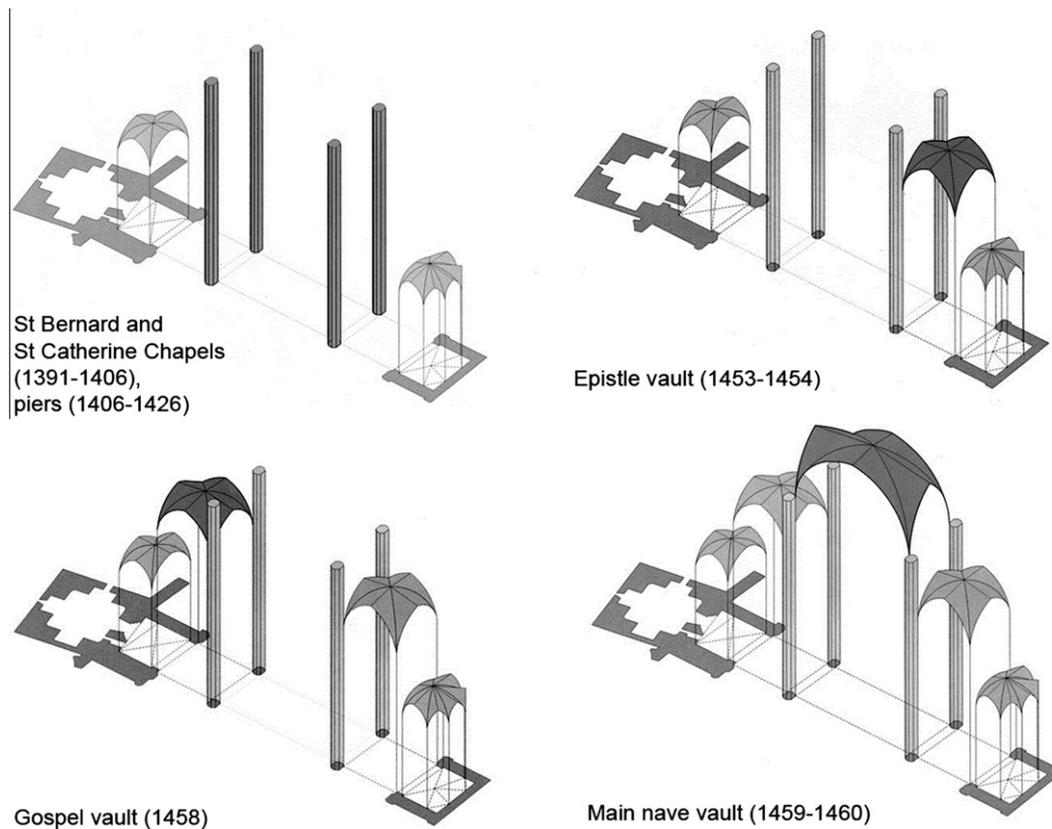
Fig. 7. Fourth bay construction stages [40,41].

The problem of structural stability at intermediate stages appears also in the transverse direction due to the construction of the lateral vaults prior to that of the central one. After the construction of the lateral vaults (Fig. 7) a transverse unbalanced thrust is applied towards the piers. Again, the possibility of the structure enduring this condition without auxiliary devices for a limited period of time can be considered. Alternatively, the centering used for the main arches of the lateral vaults may have been left active until the construction of the central one. However, in ancient construction, centerings should be normally eased to allow the work to set [56], which would in itself activate the vault. Even if the centerings were not eased, difficult equilibrium conditions would arise during their removal, causing unbalanced inward or outward thrust depending of the order of the removal operation. All these hazards seem to be confirmed by the large variability of the lateral drift measured in the piers (Figs. 5 and 6). Moreover, different approaches may have been used as well during the long construction process, adding to the variability of the lateral deformations detected across the bays. All this suggests that a significant part of the deformation may have appeared during the construction process and hence is not connected to later mechanical effects.

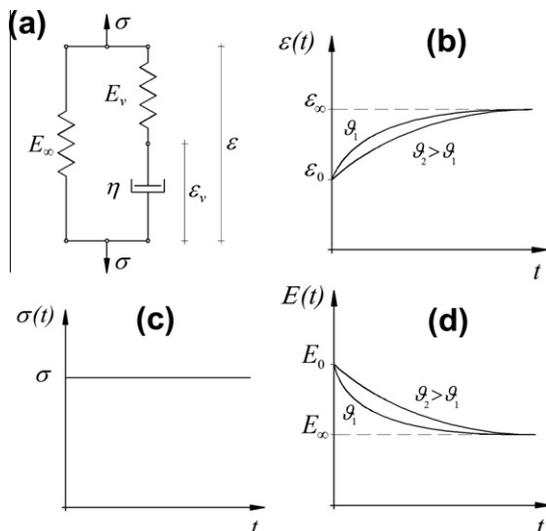
Fig. 8. Viscoelasticity model: (a) schematization through a Maxwell chain and strain (b), stress (c) and stiffness (d) time-dependent laws.

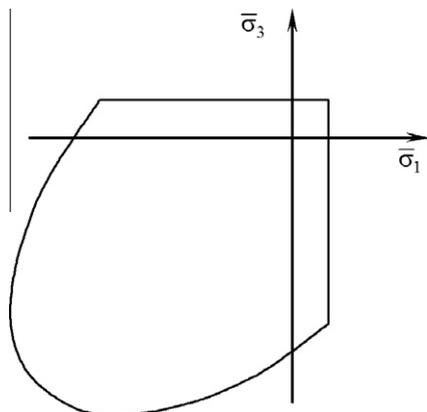
Fig. 9. Composite damage surface adopted for masonry.

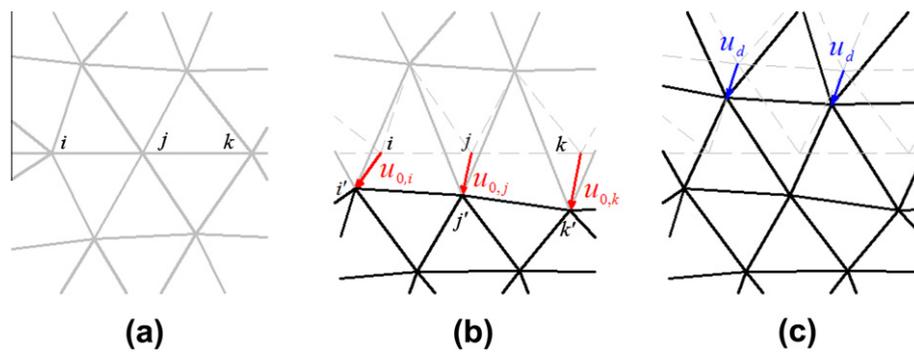
Fig. 10. FE activation technique for sequential analysis: (a) all elements inactive (in gray), (b) elements corresponding to first construction stage active (in black), and (c) elements corresponding to second construction stage active and their initial coordinates correction.

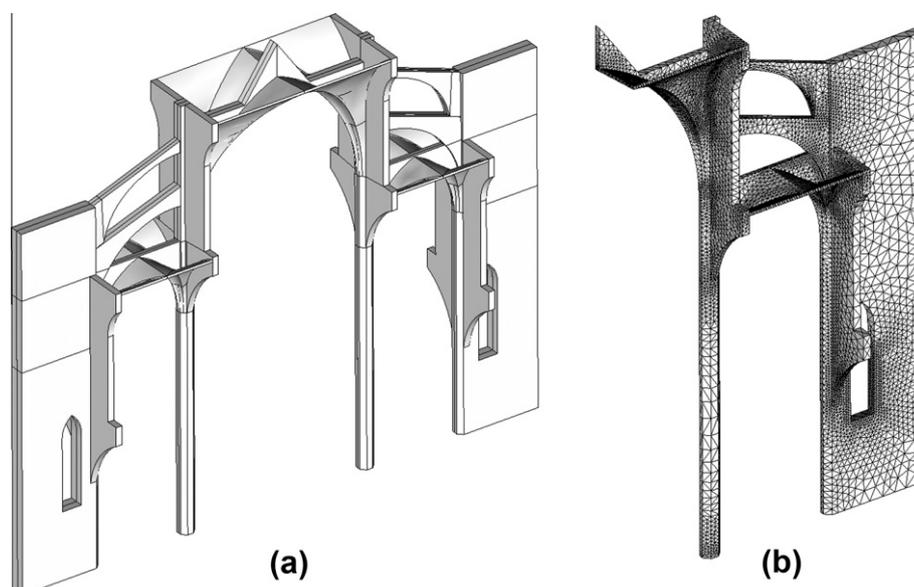
Fig. 11. Typical bay structure (a) and FE mesh (b) considered for the construction process numerical simulation.

The analysis of a single typical bay has been carried out on a structural model including piers, buttresses, flying arches, nave vaults and aisles (Fig. 11a). Such macroelement has been considered as the most representative for the purpose of investigating the possible link between construction process and existing deformation [50]. Due to symmetry of geometry and load, a three-dimensional FE model has been elaborated representing only a quarter of the typical bay (Fig. 11b). Appropriate boundary conditions have been considered in order to account for symmetry

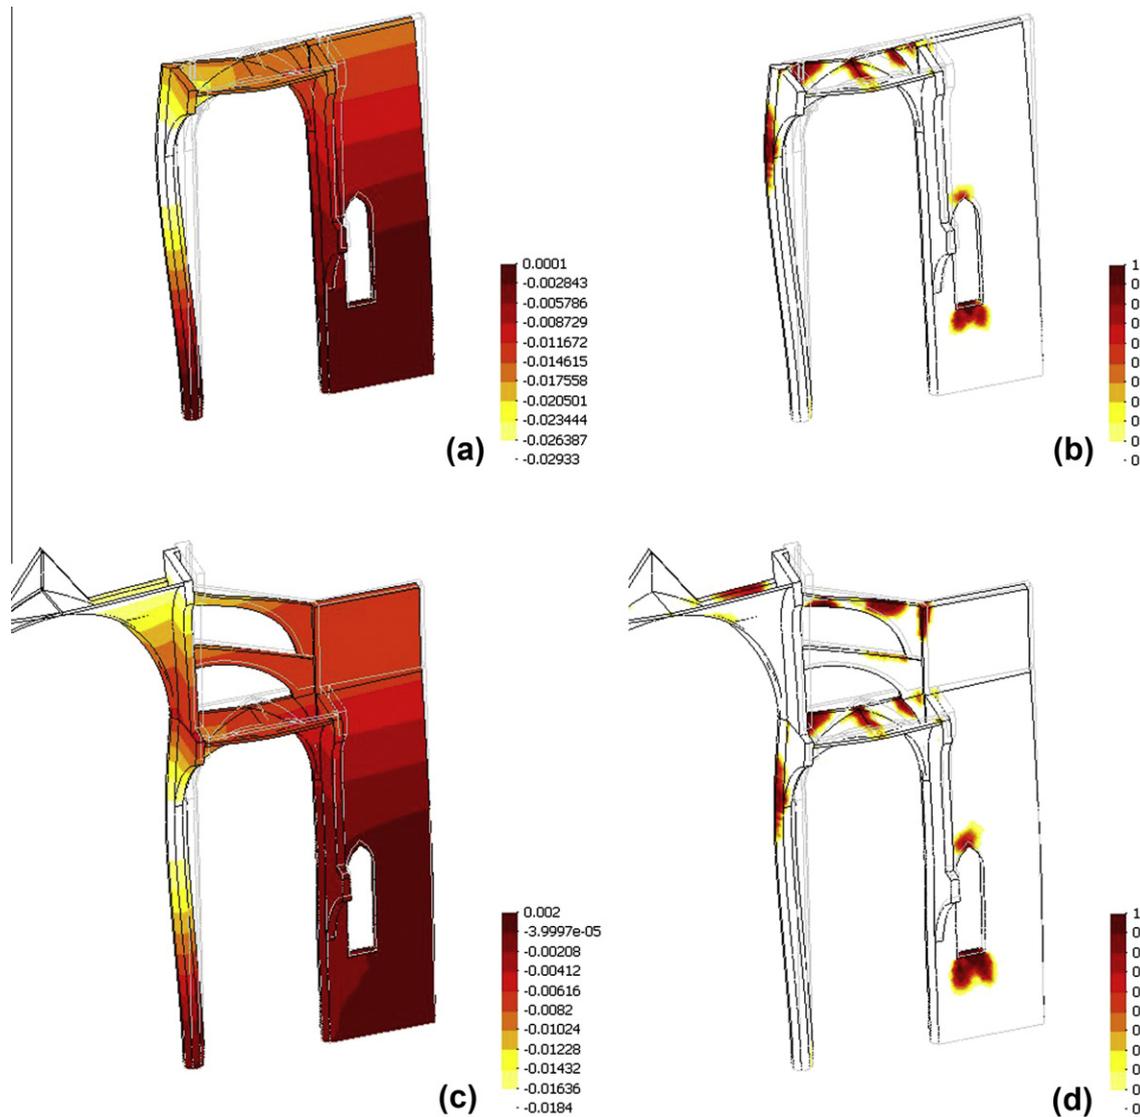
Fig. 12. Construction process simulation: first stage (a and b) and second stage (c and d). Deformed shape ($\times 50$) with horizontal displacement contour (left) and tensile damage contour (right).

The numerical simulation results of the first construction stage are represented in Fig. 12a and b, in terms of deformed shape and tensile damage. The resulting deformation at the top of the pier is equal to 3 cm. At that location, at the side towards the central nave, tensile damage occurs and also at the key of the aisle vault, at the transverse rib and at the bottom of the large window located in buttresses. Such amount of damage is actually greater than that observed on the real structure. However, the numerical analysis clearly shows that such partial configuration of the bay is stable, pointing to the possibility of the bay having been built following the supposed construction process.

The deformed shape and the tensile damage contour after the second construction stage are represented in Fig. 12c and d. The maximum lateral displacement at the pier decreases to 1.8 cm due to thrust exercised by the central vault. As in the previous

the tensile damage distribution remains similar to the one depicted in Fig. 12d, since creep does not alter the stress state of the structure under the hypothesis of geometric linearity.

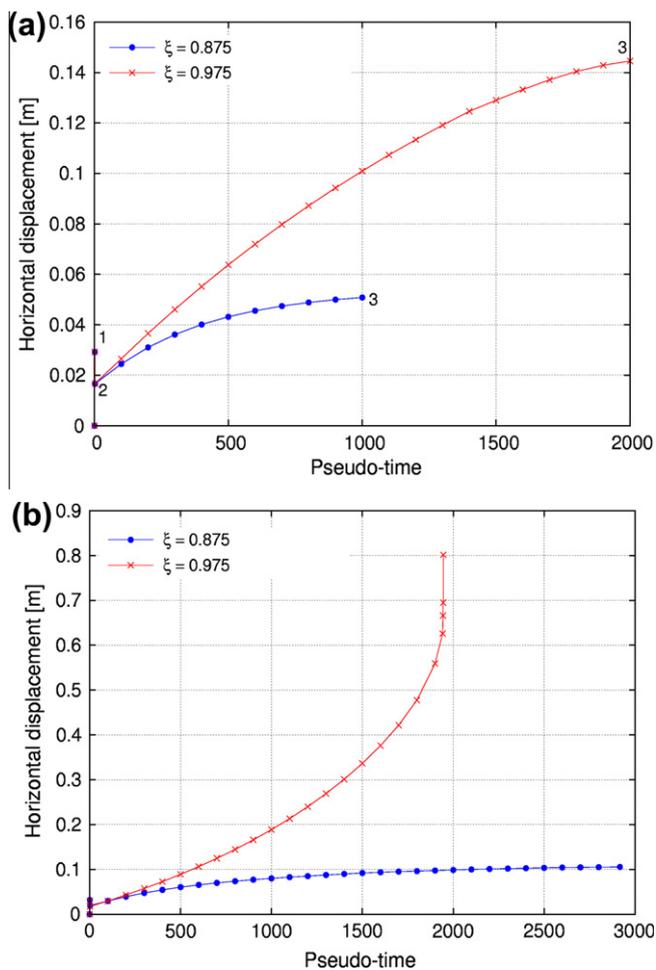
Fig. 13. Construction process simulation: horizontal displacement increase at pier top due to creep. Hypotheses of geometric linearity (a) and geometric nonlinearity (b).

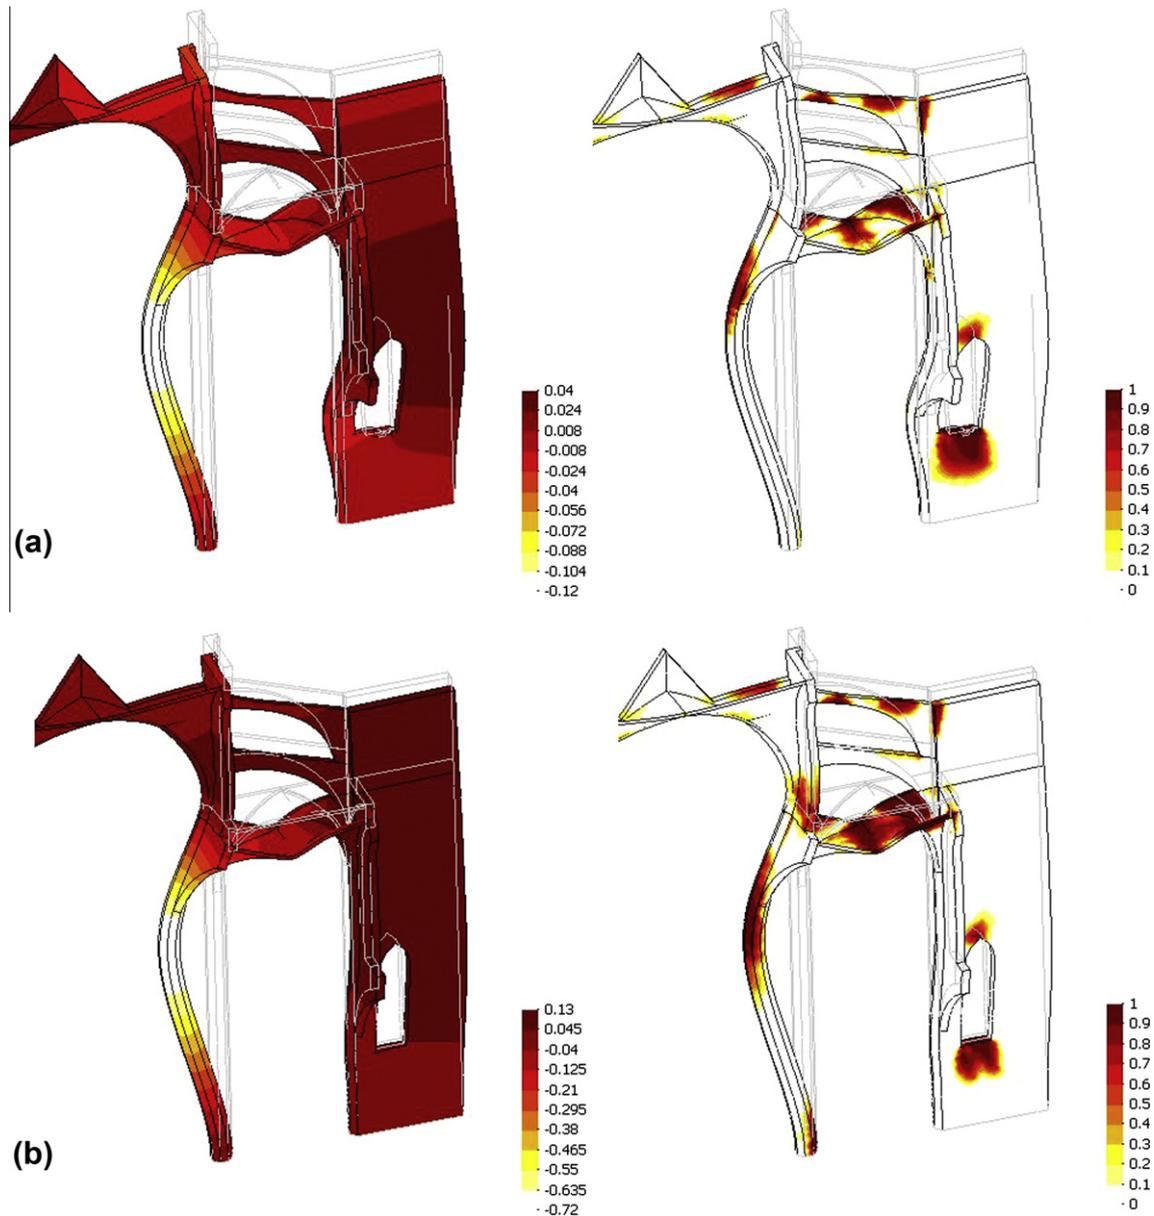
Fig. 14. Construction process simulation with geometric nonlinearity: (a) deformed shape ($\times 50$) with horizontal displacement contour (left) and tensile damage (right) for $\xi = 0.875$. (b) deformed shape ($\times 10$) with horizontal displacement contour (left) and tensile damage (right) for $\xi = 0.975$.

The assumption of $\zeta = 0.975$ in the frame of a nonlinear geometric analysis leads to the instability of the structure at 2000 time units, as shown by the corresponding curve in Fig. 13b. It can be concluded that the numerical simulation can represent the failure condition only for extremely high values of the participation ratio. However, such very high values might be realistic for very long historical periods, during which creep might acquire a low diminishing rate or even develop at an almost constant rate (secondary creep).

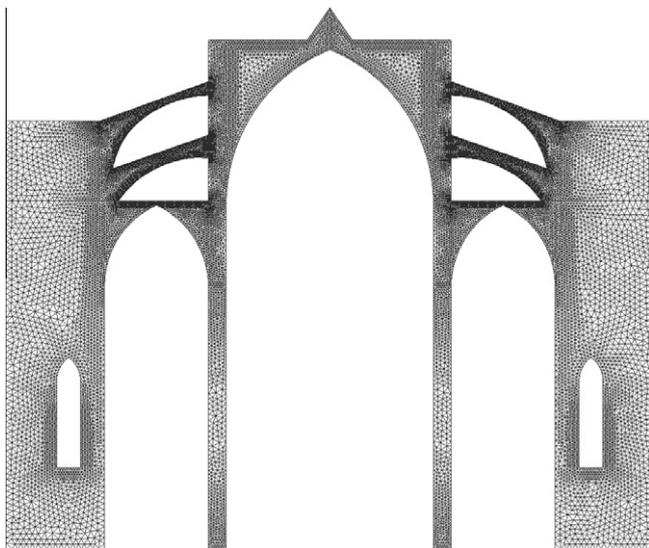
Fig. 15. FE mesh adopted for seismic load analysis.

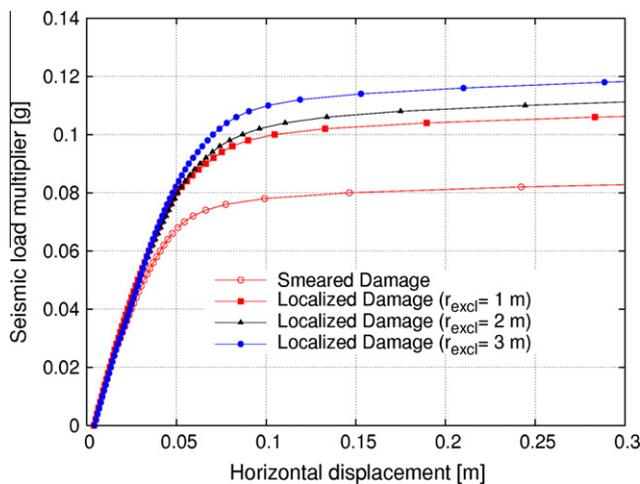
Fig. 16. Seismic load multiplier vs. horizontal displacement curves derived from smeared and localized damage models.

Fig. 16 shows the seismic load multiplier (defined as a fraction of gravity acceleration) against the horizontal displacement at the top of the piers. Note that all curves start at a nonzero displacement, which is the drift of the control point after the application of the dead weight. The smeared damage model causes failure for a load factor of about 0.08. The localized damage model produces a higher failure load factor, ranging between 0.1 for $r_{excl} = 1$ m and 0.12 for $r_{excl} = 3$ m, as expected due to restrictions that the model imposes to the formation and propagation of damage. It is worth noticing that the obtained seismic load multipliers are similar to the design values that can be determined from the Spanish seismic provisions NCSE-02 [63] for the location of the cathedral with a return period of 1000 years.

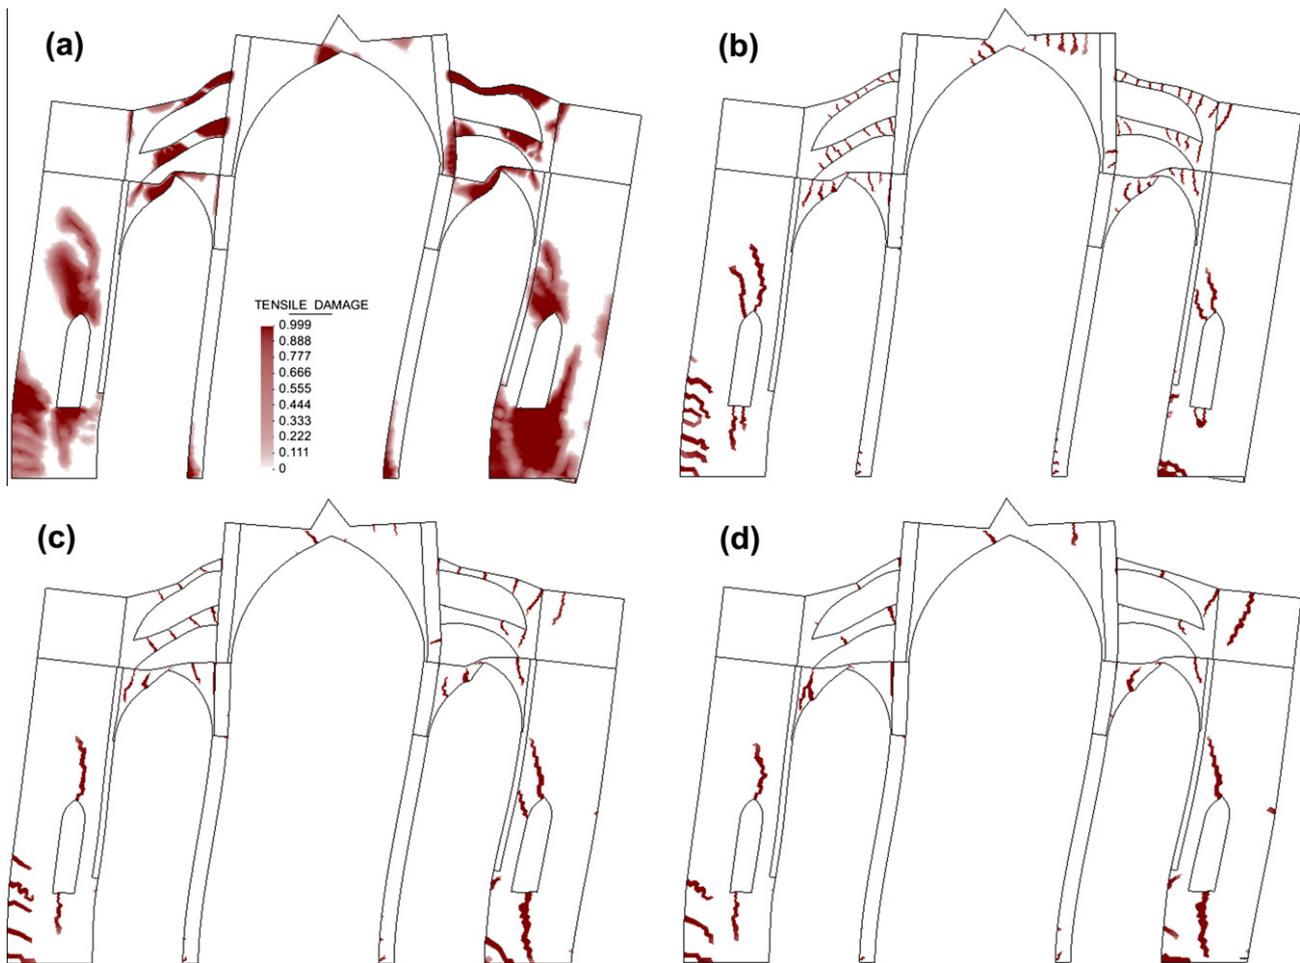
Fig. 17. Deformed shape and tensile damage obtained by seismic analysis: (a) smeared damage model, (b) localized damage model with $r_{exc1} = 1$ m, (c) $r_{exc1} = 2$ m and (d) $r_{exc1} = 3$ m.

Fig. 17 depicts the deformations and the tensile damage distribution obtained by the analyses with smeared damage model and localized damage model. The latter model affords a more realistic representation of the possible location and extent of the tensile cracks, allowing a better understanding of the real collapse mechanism under seismic loading. The more damaged portions are the base of columns and buttresses, where tensile flexural stresses are concentrated. The thin aisle vaults and the flying buttresses are also considerably cracked due to curvature inversions, showing the limited capacity of Gothic members to withstand lateral actions. The presence of the big false windows contributes to weaken the buttresses by facilitating the generation of a large crack in them. The damage is limited in the nave vault, since the diaphragmatic transverse arch above the vault provides additional transversal stiffness midway in each bay. The appearance of a limited damage in the FE model of the nave vault also may be due to difficulty in representing with a plain stress element the complex original geometry. However, some preliminary analyses presented in [50] have shown the consistency between the two-dimensional and three-dimensional FE models. The collapse is similar to the typical three-arch system mechanism with ten hinges.
